Waterford Association, Inc.

FULL RESERVE STUDY REPORT

For 30-Year Projection Period Beginning January 1, 2017

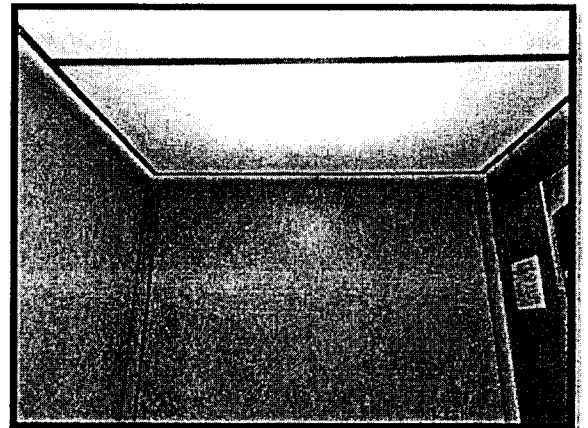
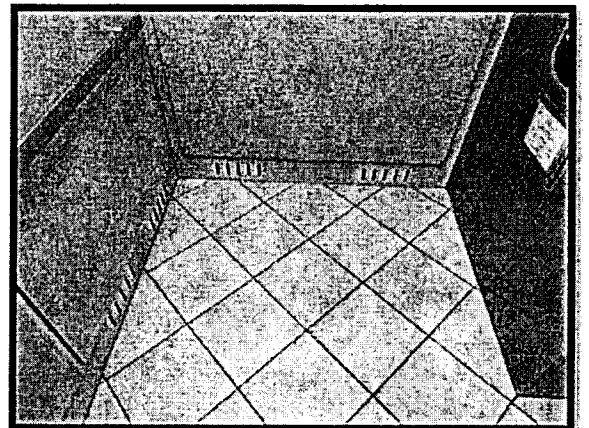
1. **Elevator Cab Finishes** – The Association maintains an elevator for each of the two buildings. The cab finishes comprise tile floors, lighted ceiling and wood panel walls. The cab finishes are in fair condition at an age of approximately 10 years. Cab finishes have a useful life of up to 20 years. The Association should budget for replacements by 2027 and again by 2047 in conjunction with a full modernization.

Figure 5 Elevator Cab Finishes

Figure 6 Elevator Cab Finishes

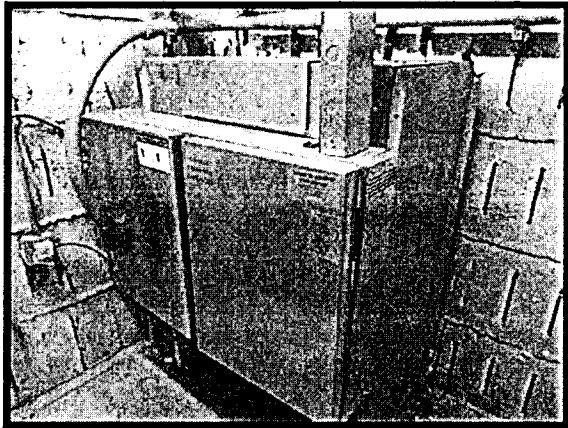
2. **Elevators, Modernization** – The Association utilizes a 2,000 pound capacity hydraulic elevator to serve four floors. Hydraulic elevator components include a cylinder, pump and controls. These components are original and in fair reported condition. The useful lives of these components vary up to 40 years. However, the Association should budget for replacements by 2047. The elevator's safety equipment should be brought up to the latest code ASME A17.1-2009. The Association should contract with an independent elevator consultant to develop specifications for elevator replacement proposals. Typical minor repairs should be funded through the operating budget.

Figure 7 Elevator Mechanical Equipment

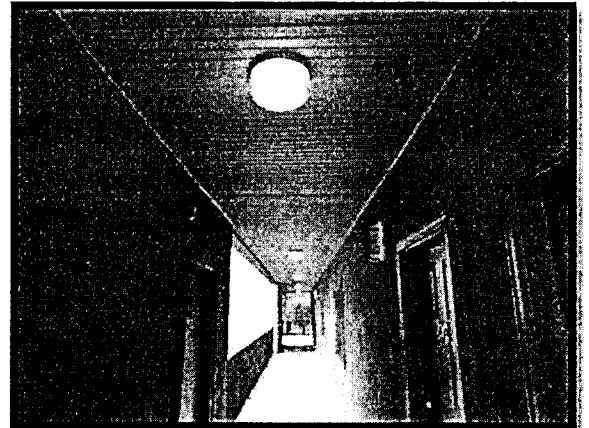
5. **Light Fixtures** – The Association maintains 48 exterior wall and ceiling mounted light fixtures located at the front of the buildings. The light fixtures are original and in good condition overall. Light fixtures of this type have a useful life of up to 25 years. Waterford should budget for replacements by 2032.

Figure 10 Light Fixtures

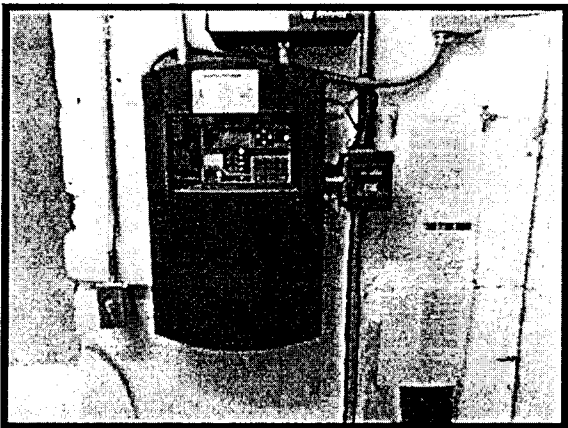
3. **Fire Alarm Systems** – The Association maintains a fire alarm system for each building. A fire alarm system comprises a main panel that controls emergency devices such as annunciators, exit signs, smoke detectors and pull boxes. The fire alarm systems are original and in good reported condition. Changes in building codes and/or technology may make a replacement necessary and/or desirable prior to the useful life of up to 25 years. Waterford should budget for replacements by 2032. Annual fire alarm system inspections are required by the National Fire Protection Association (NFPA) 722 Standards.

Figure 8 Fire Alarm Control Panel

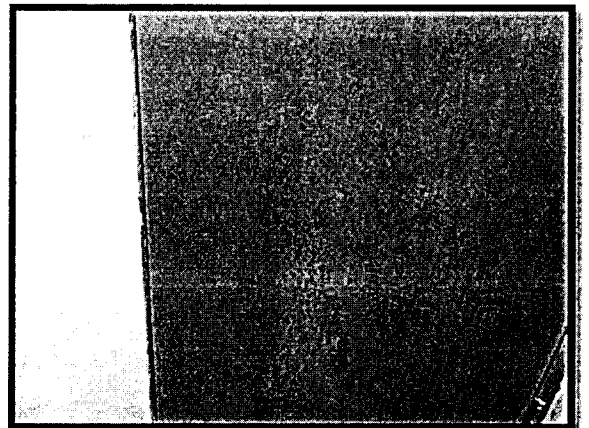
7. **Doors, Common** – Waterford maintains 14 common metal doors. The common doors are original and in fair to good condition overall. Areas of rust are noted at the rooftop doors. Doors have a useful life of up to 30 years. The Association should budget for replacements by 2037. The estimate of cost is based on fire rated self-closing doors.

Figure 11 Common Door Rust

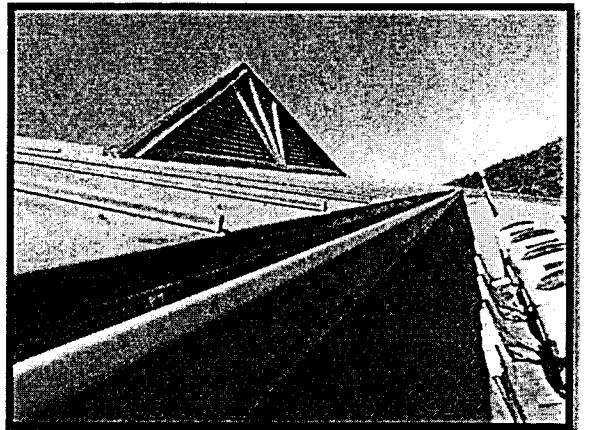
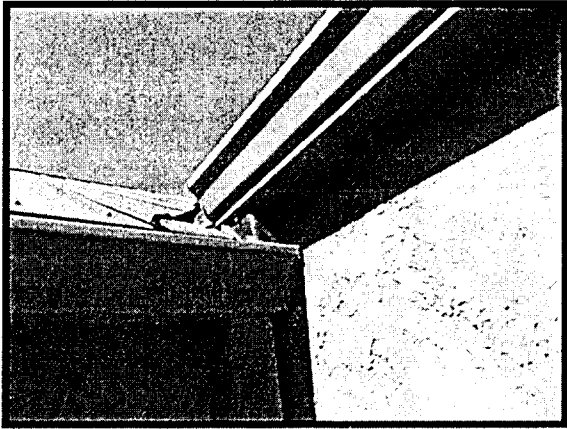
8. **Gutters and Downspouts** – Waterford utilizes approximately 2,825 linear feet of gutters and downspouts that are designed to collect rain water from the roofs and shed the water away from the buildings. The gutters and downspouts are original and in good condition. Gutters and downspouts have a useful life of up to 35 years. The Association should budget for replacements by 2042 in conjunction with roof replacements. The Association should utilize downspout extensions and splash blocks at discharge areas to direct the water away from foundations. An estimate provided by the Board for repairs related to water intrusion is included in 2017.

Figure 12 Gutter

Figure 13 Gutter System

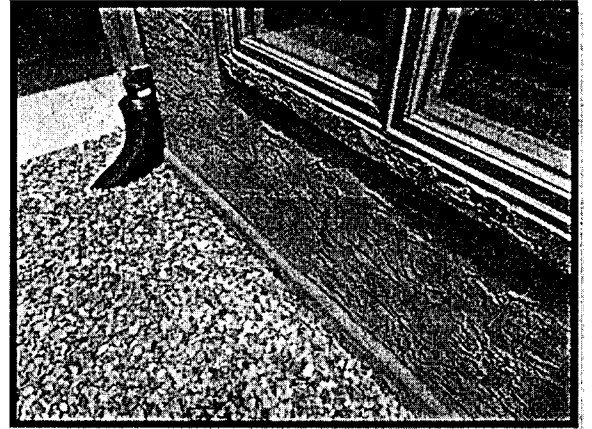
14. **Walls, EIFS Repairs** – The Waterford exterior cladding comprises an EIFS system. The Board provided an exterior cladding inspection report by Southern Inspection Co., Inc. The report notes leaks at windows. Significant areas of bubbling and cracking are noted. Pages 3 and 4 of Appendix B depict this condition assessment in Figures 14 through 16 and 20. Potential water intrusion problems with this type of cladding systems are improperly installed diverter flashing at roof and wall intersections allowing water to get behind the cladding and unsealed balconies. Ripping off the EIFS is a last resort. It is important to keep the EIFS clear of ground surface water with proper drainage. The Association should plan for EIFS repairs in 2017. The repair project should include sealing up the building envelope in conjunction with creating a drainable EIFS system. The estimate of cost will vary pending the outcome of a forensic investigation. A management company is recommended for an anticipated project of this size.

Figure 16 EIFS Bubbling

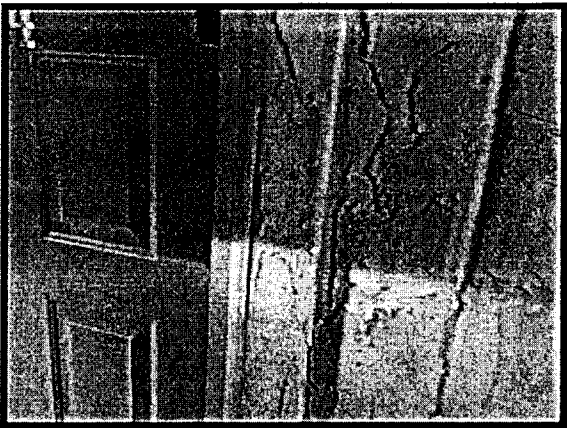
Figure 14 Door Frame Sealant Missing

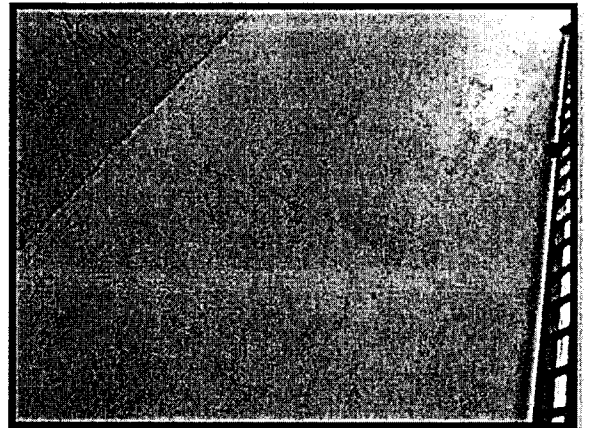
6. **Balconies and Breezeways, Waterproof Coatings** – Waterford maintains 6,900 square feet of balconies and breezeways. The balconies and breezeways are original and in good condition overall. Areas of cracks and missing sealants between the breezeways and buildings are noted. Pages 3 and 4 of Appendix B depict this condition assessment in Figures 17 through 19. Balconies and breezeways have a long useful life with the benefit of periodic maintenance. Concrete cracks and spalling occurs from the expansion of the reinforcing steel bars due to corrosion. Concrete corrosion is caused by rainwater and chlorides getting into the concrete down to the level of the reinforcing. Failure to maintain the balconies and breezeways can lead to costly repairs. The Association should budget for waterproof coating applications and partial repairs as needed by 2022 and every five years thereafter except when paint finish applications occur.

Figure 17 Breezeway Crack

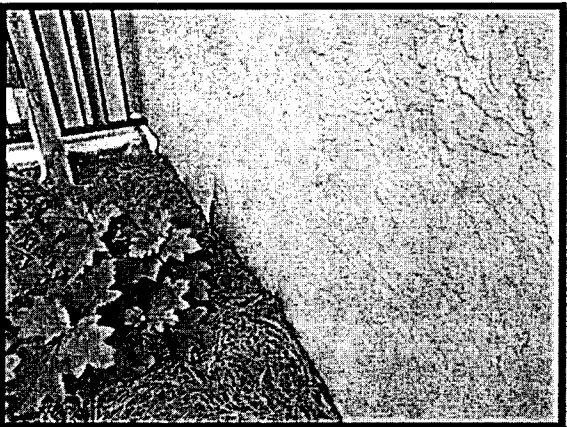
Figure 15 EIFS Deterioration

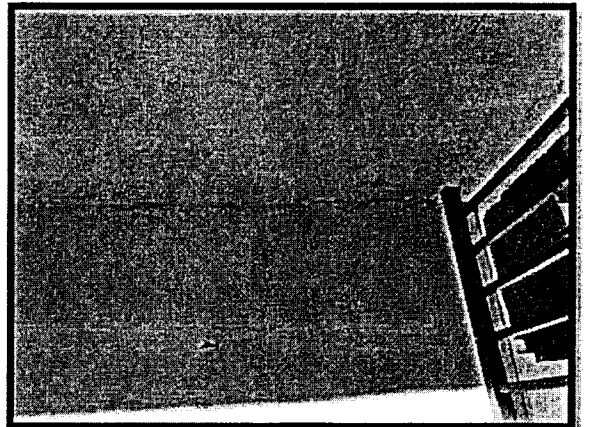
Figure 18 Breezeway Sealant Missing

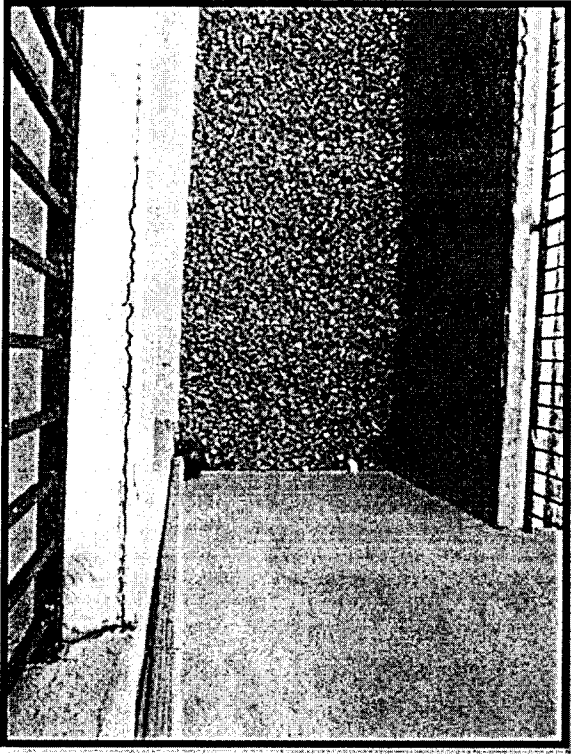
Figure 19 Breezeway Edge Cracking

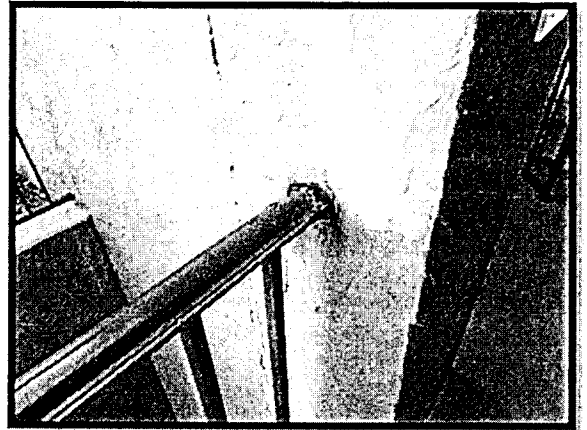
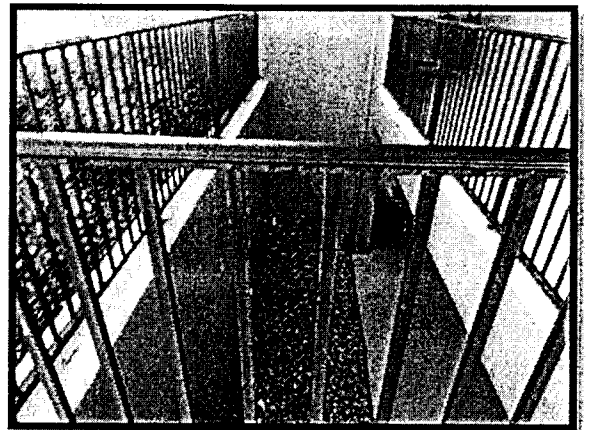
10. **Railings, Metal** – The Association maintains 3,040 linear feet of metal railings. The railings are original and in good condition overall. Areas of rust are noted. Page 4 of Appendix B depicts this condition in Figures 21 and 22. Metal railings have a useful life of up to 35 years. Waterford should budget for replacements by 2042. An allowance for paint finish applications is included in Line Item “**Walls, Paint Finish Applications**”.

Figure 21 Railing Connection

Figure 22 Metal Railing Rust

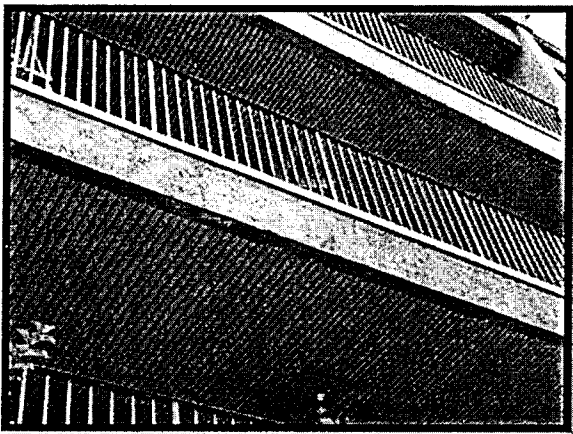
Figure 20 Balcony Fascia Beam Deterioration

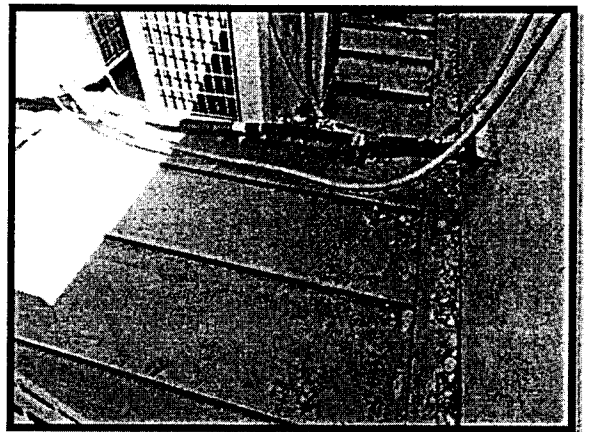
11. **Roofs, Flat** – The Association maintains 15 squares of flat roofs located at the HVAC areas. The original flat roofs are currently metal and in fair condition overall.

Figure 23 HVAC Area

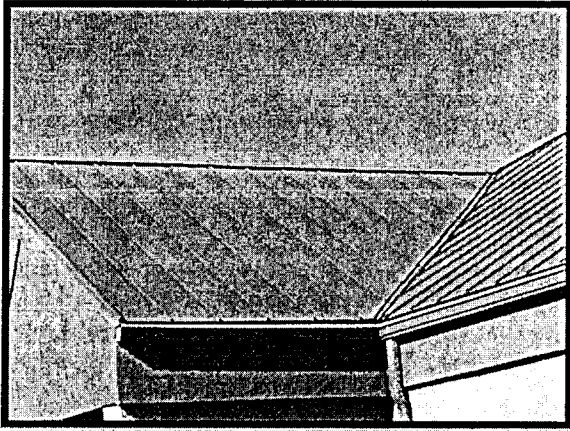
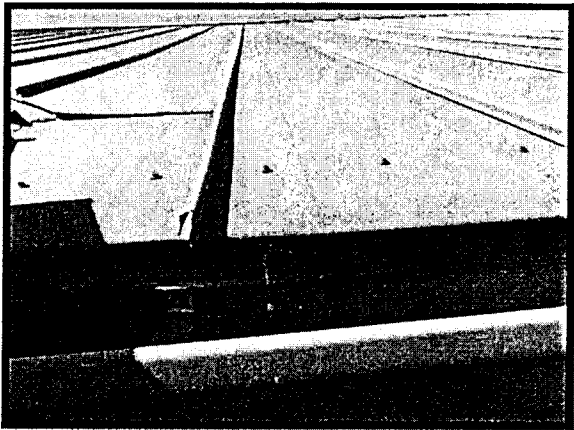
12. **Roofs, Metal** – There are approximately 260 squares of standing seam metal roofs. Roof panels are crimped together rather than fastened by screws. The metal roofs are original and in good overall condition. Metal roofs of his type have a useful life of up to 35 years. The Association should budget for replacement of the metal roofs by 2042. The estimate of cost is based on a 24-gauge steel with a zinc aluminum metallic coating.

Figure 24 Metal Roof

Figure 25 Metal Roof

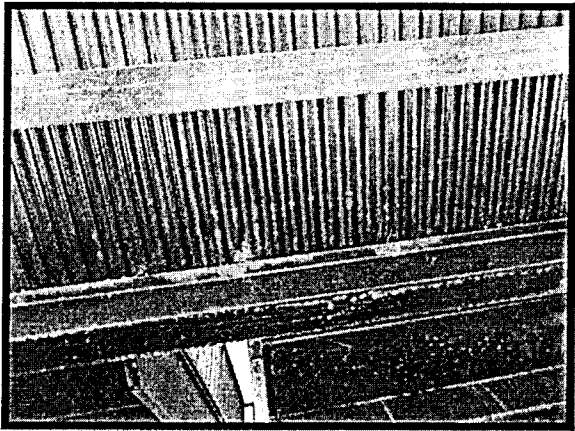
Figure 26 Stairwell Rust

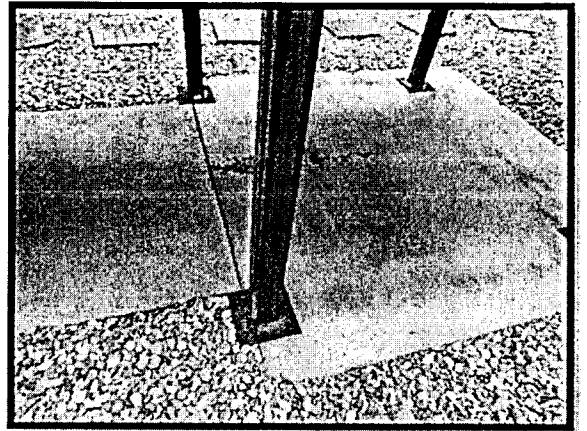
Figure 27 Column Corrosion

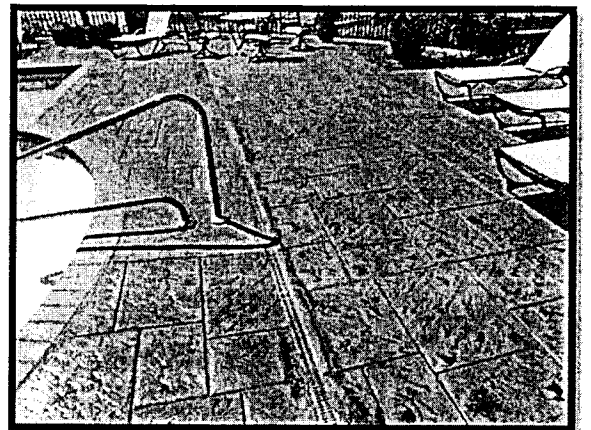
15. **Deck, Concrete Coatings** – The pool deck comprises 2,690 square feet of concrete. The pool deck and the coating is in good condition at an age of less than one year. Concrete pool decks have a long useful life with the benefit of periodic maintenance. Periodic maintenance includes a slip resistant coating application every 8- to 12-years. Waterford should budget for the next coating application by 2027 and every seven years thereafter.

Figure 28 Pool Deck

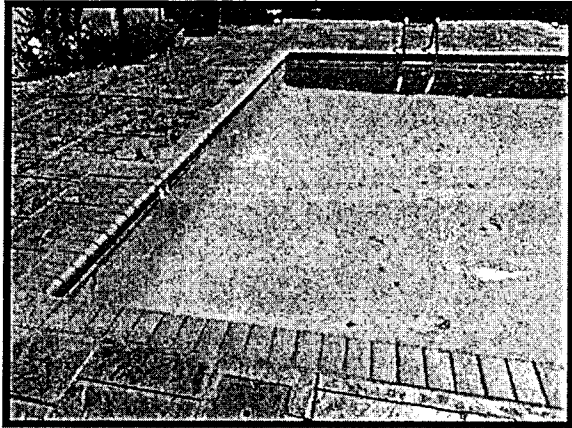
16. **Pool Finish** – The Association maintains approximately 835 square feet of horizontal pool finish. The pool finish is original and in fair overall condition. The pool finish has a useful life of 8- to 12-years. Waterford should budget for resurfacing of the pool finish by 2021 and every 10 years thereafter. Typically minor upgrades will be needed to bring the pool up to current code. An allowance for replacement of the waterline tile is included in the estimate of cost.

Figure 30 Pool

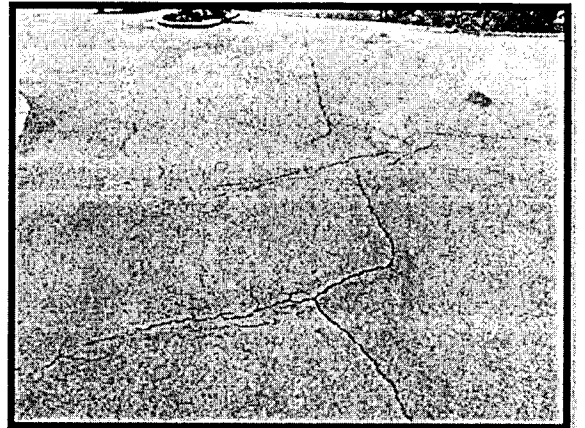
18. **Asphalt Pavement, Preservation** – As previously mentioned, there are approximately 4,725 square yards of asphalt pavement. The asphalt pavement is original and in fair overall condition. We note areas of isolated cracks. Page 6 of Appendix B depicts this condition in Figure 33. The Association should repair any isolated areas of deteriorated pavement prior to asphalt coating applications.

Figure 33 Asphalt Pavement Cracks

Proposals for asphalt coating applications should include both crack seal repair and area patching. These activities reduce water infiltration and the effects of weather. The contractor should only apply asphalt coating applications after crack and surface repairs are completed.

The asphalt coating has a useful life of five- to eight-years. Waterford should plan for an application of pavement preservation in 2018. Subsequent cycles are likely every five - to eight-years thereafter except when replacement occurs. An estimate provided by the Board for drainage installation to the lower parking area is included in 2017.

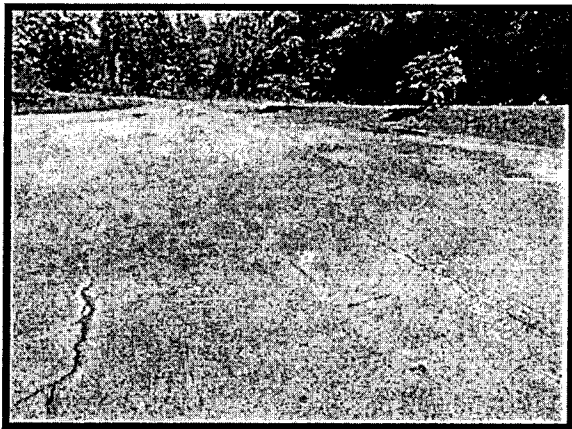
17. **Asphalt Pavement, Mill and Overlay** – The Association maintains approximately 4,725 square yards of asphalt parking areas. The asphalt pavement is original and in fair overall condition. Asphalt pavement comprises multiple layers. Typically the top layer or surface course deteriorates over time and can be milled or removed and overlaid or replaced. The following diagram depicts typical pavement layers.

Figure 31 Asphalt Pavement Overview

A combination of area patching, crack repair and milling should occur before the overlayment. Areas that exhibit potholes, alligator cracks and areas of pavement that are deteriorated from vehicle fluids should all be repaired prior to overlayment. Area patching may require total replacement of isolated areas of pavement. The base course for residential subdivision roadways designed for light traffic is often six inches thick. The paving contractor should seal all cracks. Crack repair minimizes the chance of underlying cracks coming through the overlayment.

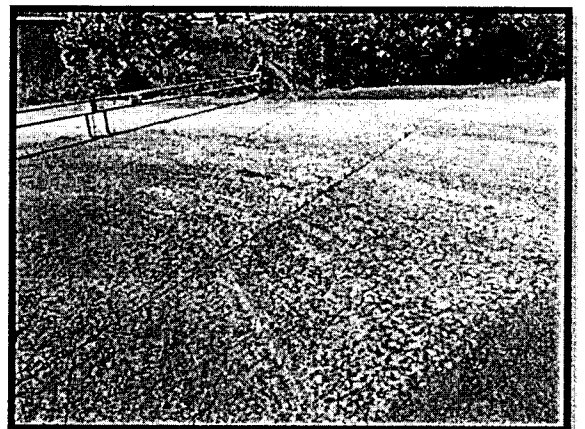
19. **Boat Ramp, Concrete** – The Association maintains approximately 3,750 square feet of concrete boat ramp. The boat ramp is in fair overall condition at an estimated age of 20 years. Boat ramps of this type have a useful life of up to 30 years. The Waterford should budget for replacement by 2027.

Figure 34 Boat Ramp

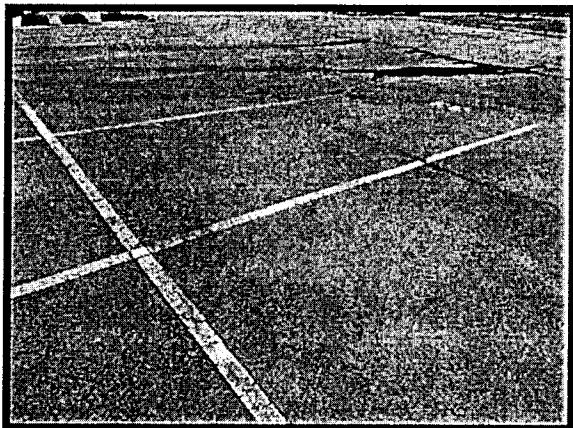
Figure 32 Pooling Water

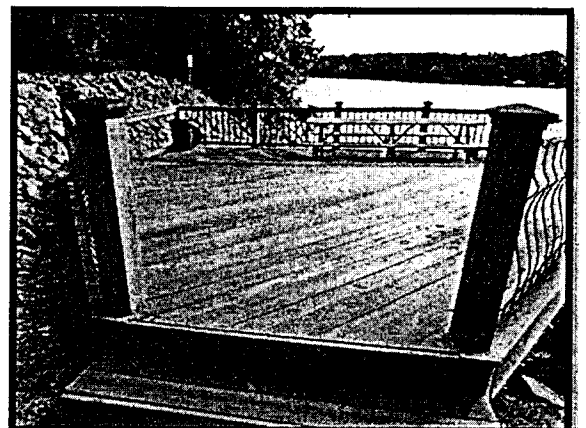
20. **Deck, Wood** – The Association maintains approximately 450 square feet of wood decking located at the south east section of the property. The decking is original and in fair overall condition. The useful life of this type of decking is from 15- to 20-years. Waterford should budget for replacement by 2026 and again by 2046. The costs noted in the expense spreadsheet are based on an azek^T composite. Azek requires little maintenance. Cleaning

Figure 35 Wood Deck

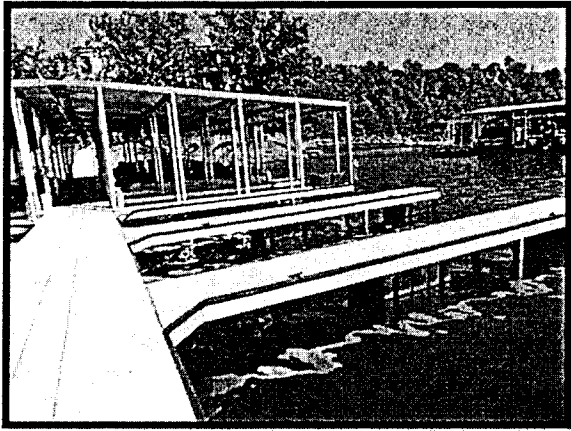
21. **Docks, Decking** – The Association maintains approximately 8,725 square feet of decking. The decking is original and in fair overall condition. The useful life of this type of decking is up to 20 years. Waterford should budget for replacements by 2031. The estimate of costs includes replacement of the floats as needed. Cleaning should be funded through the operating budget as needed. Typical minor repairs and replacements should be funded through the operating budget.

Figure 36 Docks

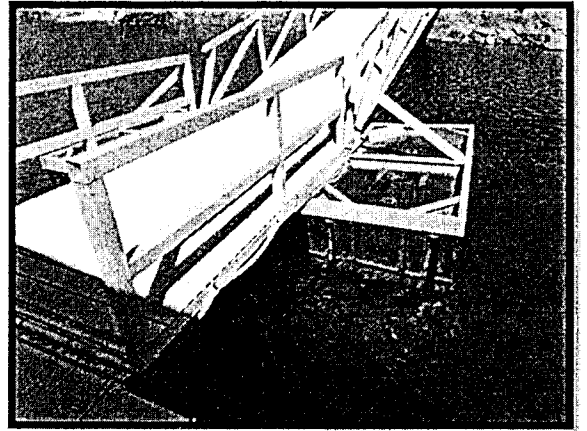
23. **Gangways, Aluminum** – There are approximately 1,330 square feet of aluminum gangways that connect the docks to the shoreline. The gangways are original and in good condition overall. Roofs of his type have a useful life of up to 25 years. The Association should budget for replacement of the gangways by 2036.

Figure 39 Gangway

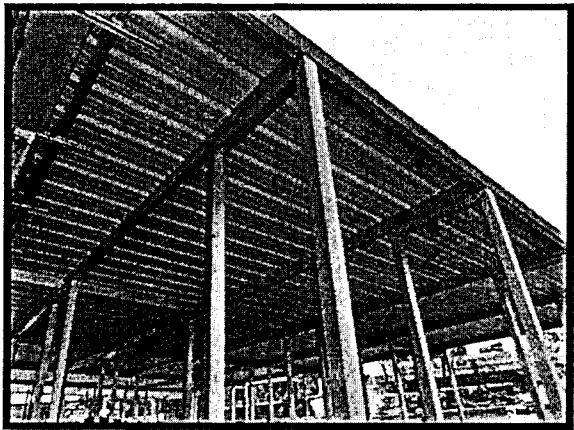
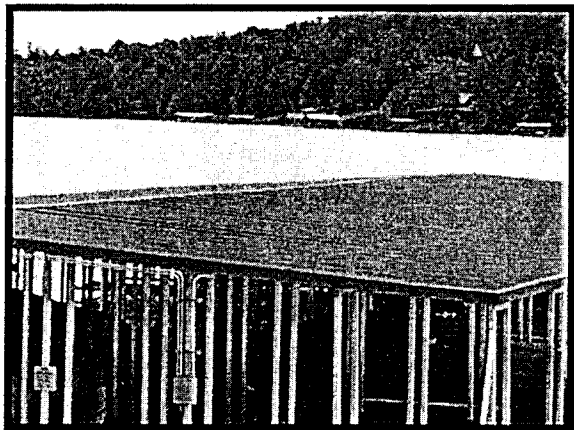
22. **Docks, Roofs** – There are approximately 19,315 square feet of roofs atop the docks. The roofs are original and in good condition. Roofs of his type have a useful life of up to 30 years. The Association should budget for replacement of these roofs by 2041.

Figure 37 Dock Roof

Figure 38 Dock Roof

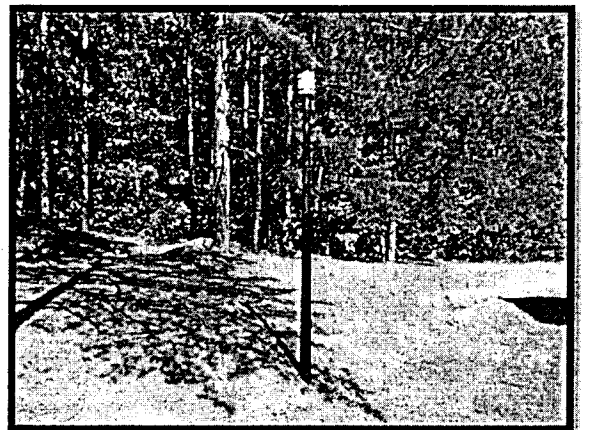
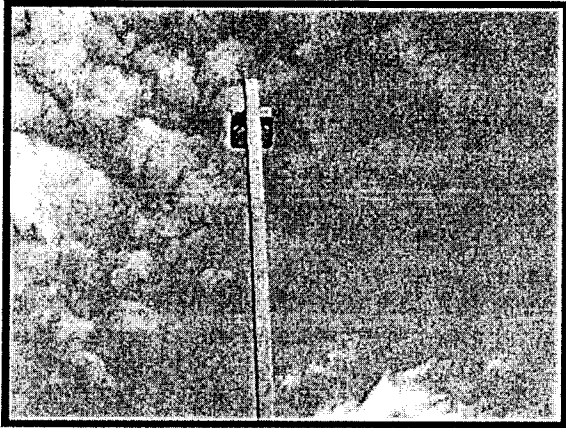
24. **Light Poles** – The Association maintains 23 light poles and fixtures. The light poles are original and in good condition overall. Some of the finishes on the tall poles is faded. Light poles have a useful life of up to 30 years. Waterford should budget for replacements by 2037. Interim fixtures should be funded through the operating budget as needed.

Figure 41 Decorative Light Pole

Figure 42 Light Pole

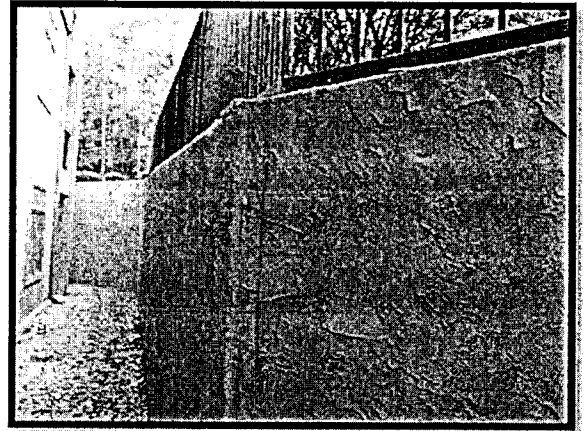
26. **Retaining Walls** – The Association maintains approximately 3,900 square feet of concrete retaining walls. Retaining walls provide lateral support to vertical slopes of soil. The retaining walls are original and in good condition overall. There are no areas of weep

Figure 45 Retaining Wall

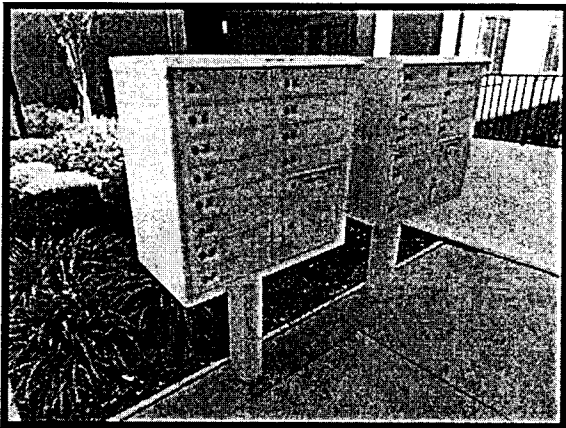
25. **Mailboxes** – Waterford maintains four mailbox stations. The mailbox stations are original and in good condition. Metal mailboxes have a useful life of up to 30 years. The Association should budget for replacements by 2037. The Association should verify new mailboxes meet the specifications of the United States Postal Service.

Figure 43 Mailbox Station

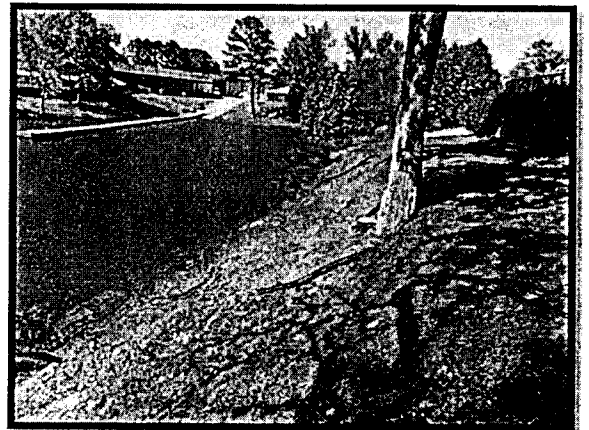
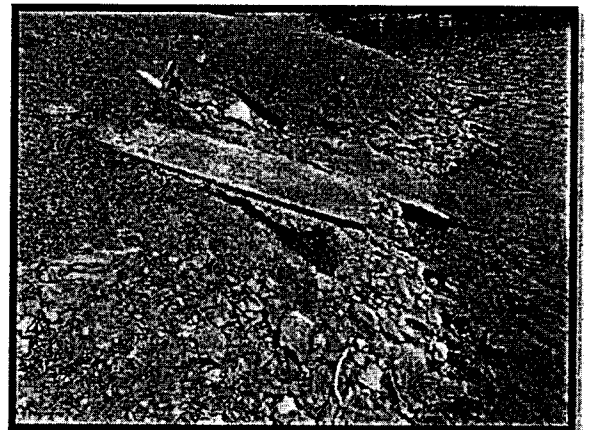
27. **Shoreline Stabilization** – The shoreline comprises 600 linear feet. The shoreline partially utilizes rip rap for erosion control. Shoreline erosion can be caused by a variety of natural factors including steep slopes, changes in water elevation and storm water runoff. Erosion can lead to partial dredging. Waterford should budget for erosion control of up to twenty percent (20%) of the shorelines every 20 years or by 2027 and again by 2047 based on the condition.

Figure 46 Shoreline

Figure 47 Shoreline Erosion

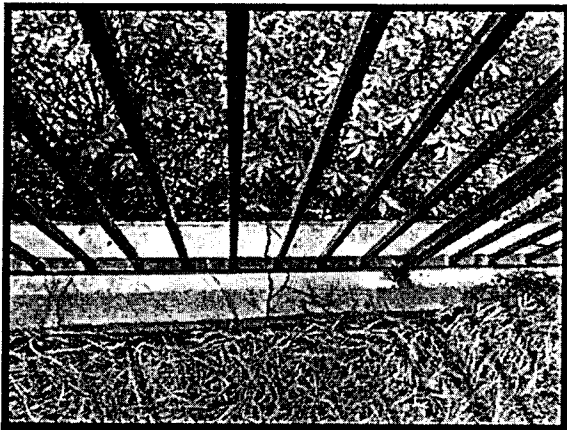
Figure 44 Retaining Wall Crack

holes noted. Retaining walls of this type have a long useful life. Waterford should budget for partial replacements of up to forty percent (40%) by 2047. The estimate of costs and times will vary. However, the Association should make sure a waterproof coating is installed at the time of repairs. Interim weep hole installation should be funded through the operating budget in the near term.
